CAPAY DIVERSION DAM MODERNIZATION FOR SUSTAINED IRRIGATION DEMAND

George V. Sabol, PhD, PE¹
Tim O'Halloran²
Michael Horgan³

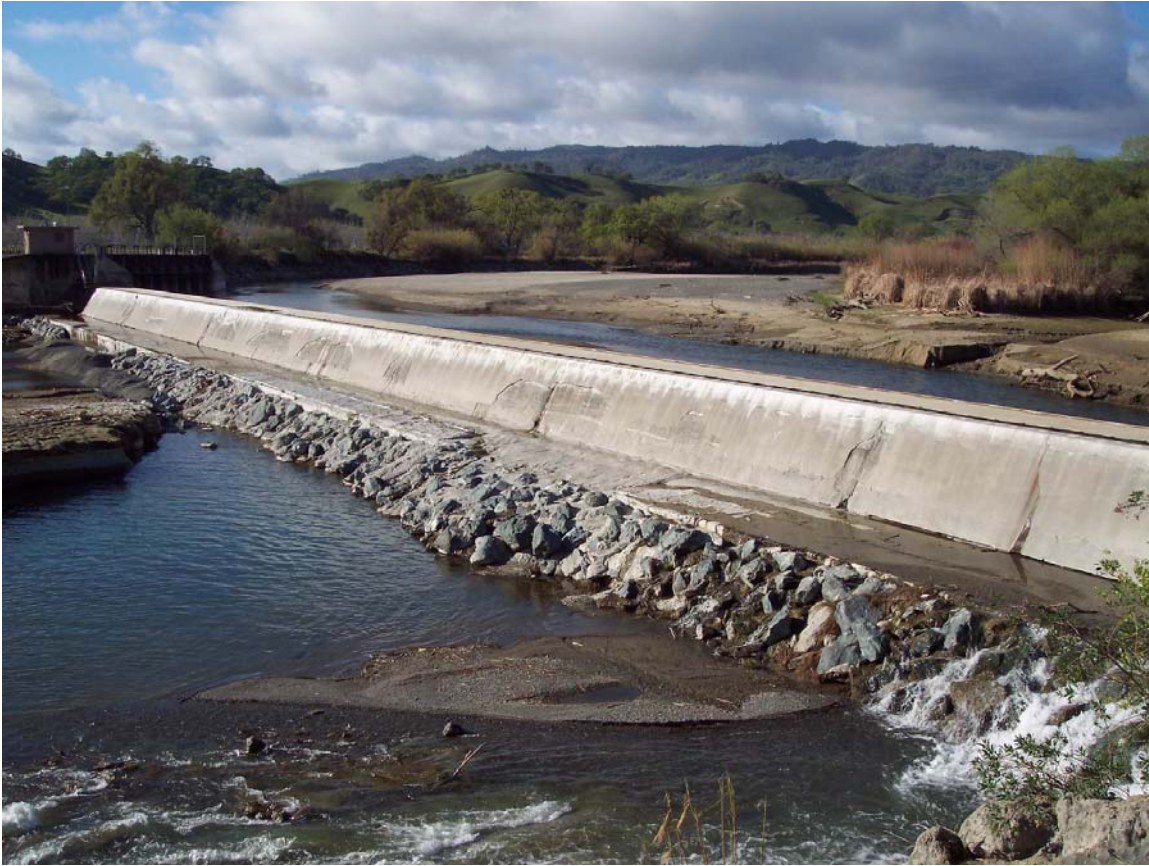
Figure 3. Photo of Capay Diversion Dam showing Cache Creek streambed degradation and local scour at end of apron

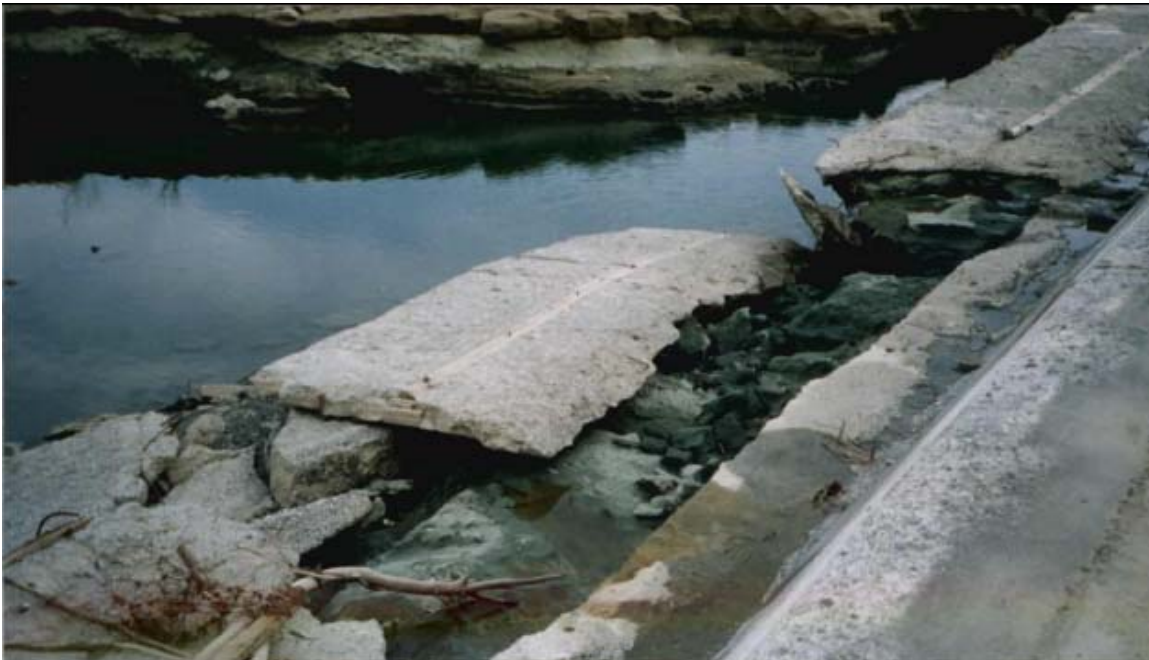
In 2003, a section of the apron failed (Figure 4) resulting in an emergency repair. The cause of the partial apron failure was not confirmed but was probably due to the combined effect of streambed degradation, scour at the end of the apron, and concrete erosion of the apron due to sediment impact.

Figure 4. Partial failure of apron of Capay Diversion Dam in 2003

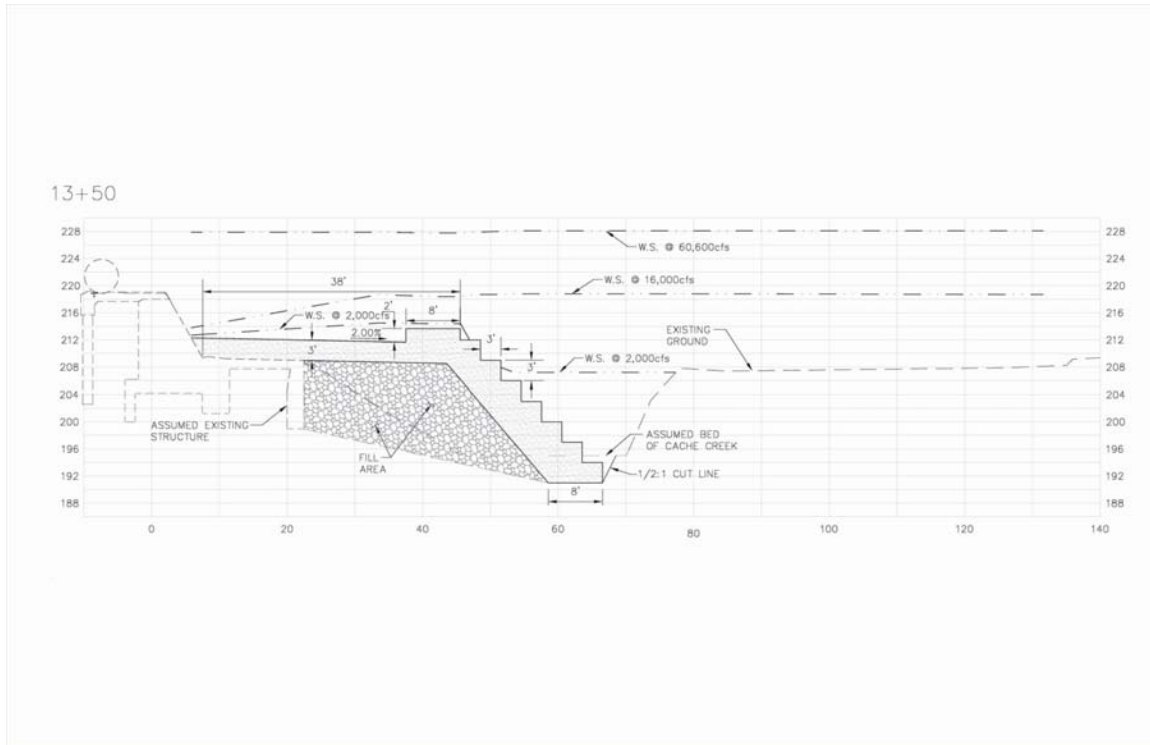
Figure 5. Illustration of replacement apron for Capay Diversion Dam

Alternatives for apron replacement were evaluated and the preferred alternative was selected. Apron replacement will be by use of roller compacted concrete (RCC). The apron will be lengthened to contain the energy of the hydraulic jump and a deeper cutoff wall will be employed to protect against local scour, (see Figure 5). The apron replacement will incorporate structural reinforcement of the abutment walls. A grade control structure will be constructed in Cache Creek a short distance downstream of the dam. That structure will provide protection of the dam against continued streambed degradation. Construction of the apron replacement is scheduled for fall 2009 at the end of the irrigation season. A major factor in the selection of RCC as the construction material is the short construction window between the end of the irrigation season and the start of the uncontrolled winter runoff in Cache Creek.
