# **DESIGN AND INSTALLATION OF A FLUME TO MONITOR SPRING DISCHARGE AT THE HEADWATERS OF THE VERDE RIVER**

Curt Kennedy<sup>1</sup>

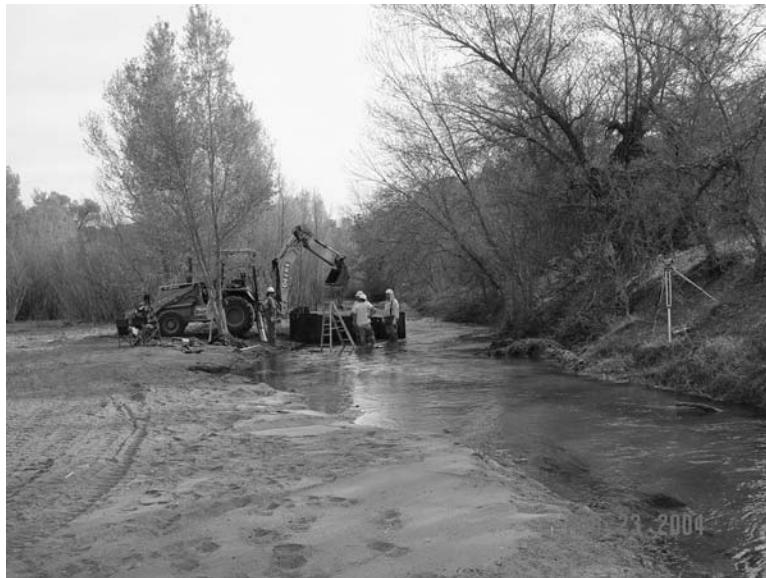
Photo 1.

Effectively addressing the issues of constructing on an unconsolidated alluvial material and channel slope variability are critical to the longevity and accuracy of this flume. At this site we chose to use sheet piles to control these variables. Photo 1 shows the initial installation of sheet piles to develop a dry working area and define the perimeter of the flume. Later in construction sheet piles would be used to form sub-surface walls to control scour, return the channel to the flume after floods, and stabilize the channel's slope. Photo 2 shows the outline of the concrete flume prior to restoring flow. The workers are cutting sheet piles to the finish contour of the concrete.

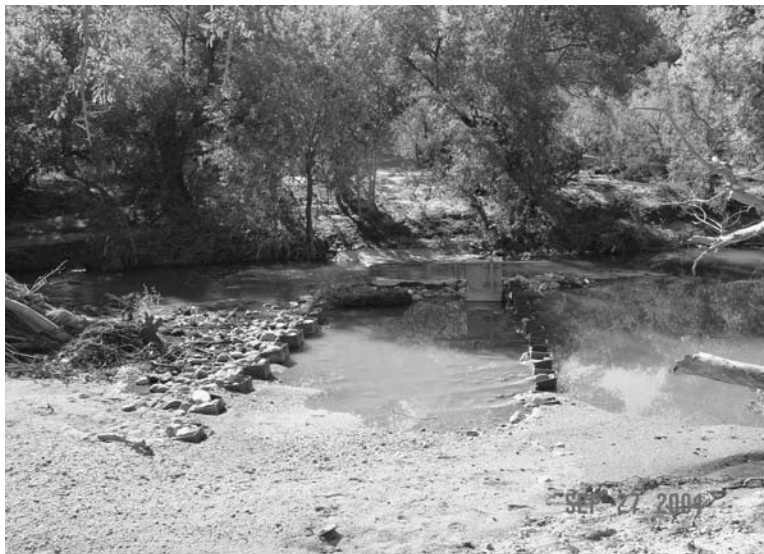
Photo 3.

Photo 3 shows the site after a 25,000 cfs flood flow with the scour walls exposed. These walls serve to minimize scour and return the base flow channel to the flume. Note that the walls are angled downstream, and are sloped up from the base flow channel to the high flow channel banks. This forces the channel to return to the flume; as the flood flows recede, water moving downstream is forced to change direction back toward the low flow channel as it brakes over the pile wall. This process continues as the flood flows recede.

Determination of how deep to construct the scour walls was done with a scour depth analysis. Because the scour process is quite variable, two different methodologies were used to predict scour depth and then compared. The primary factors controlling scour depth are flood size and particle size and distribution. At

this site scour depths were predicted to reach 3 meters, this 3 meter value was used as the depth of the subsurface wall.

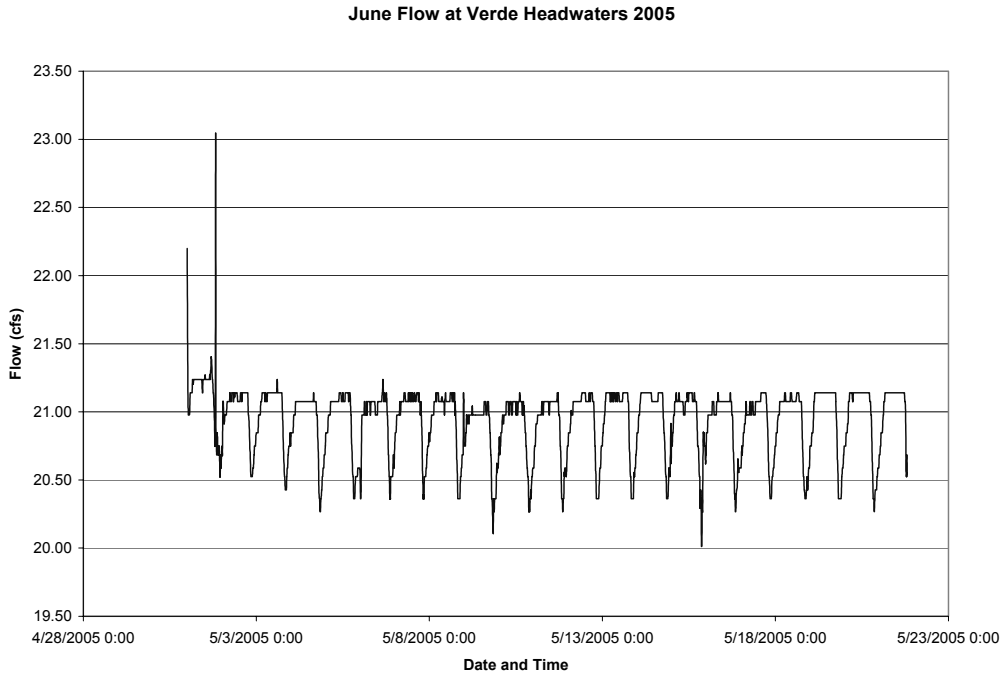
Figure 4.

Under normal base flow conditions the spring's discharge as measured through the flume has shown the diurnal patterns associated with plant evapotranspiration. One notable exception occurred consistently on Sunday afternoons where a 0.5 cfs – 1 cfs drop in flow would occur. It turns out that marijuana growers were pumping water from the Verde River upstream of the flume, this stopped when the field was discovered by law enforcement.

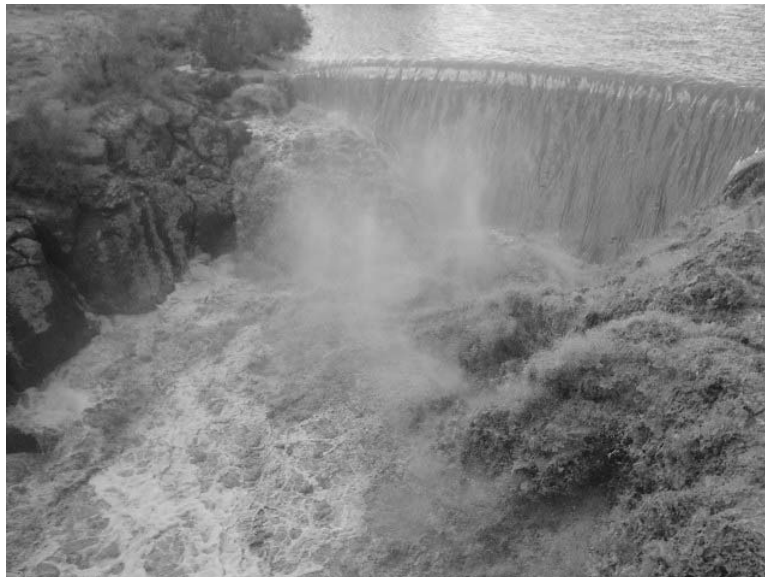
Photo 4.

The flume’s first winter/spring runoff season was notable in that three major flood flows occurred; the highest flow being approximately 25k cfs. Photo 4 was taken approximately five miles upstream of the flume by a local resident at Sullivan Dam. These floods exposed the tops of the sheet pile walls and shorted the satellite communicator. The sheet piling was covered with native alluvium by a backhoe in approximately ½ day, the satellite communicator was replaced. The flume and instrument package were unharmed.
