MACHU PICCHU: ITS ENGINEERING INFRASTRUCTURE

Kenneth R. Wright¹

Ruth M. Wright²

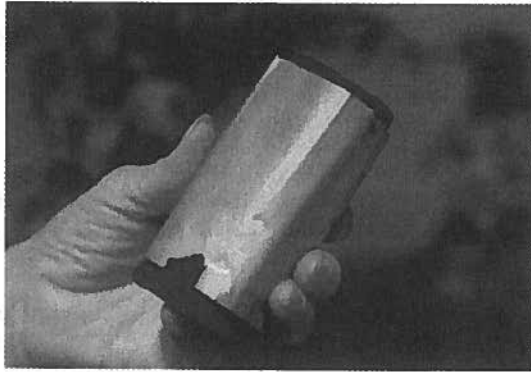
Fig. 2. The Machu Picchu gold bracelet found buried adjacent to an early stone wall which itself was buried west of the Temple of the Condor. The bracelet now resides in the Cusco Regional Museum.

6. Exploration of new hydraulic components and of miscellaneous general interest features. A gold bracelet was discovered in one of the excavations for our agricultural soil samples (Fig. 2).

Our scientific research interests extended to the agricultural production potential of ancient Machu Picchu (Wright, Wright, Jensen & Valencia). We conducted complete agronomic soil tests at the Colorado State University Soils, Water and Plant Testing Laboratory in 1996 on samples excavated by Señorita Elva Torres Pino of the INC. In obtaining a soil sample in one of the plazas, an ancient Inca wall was uncovered. At the foot of this long buried wall a gold bracelet was discovered—the only gold object ever found at Machu Picchu.

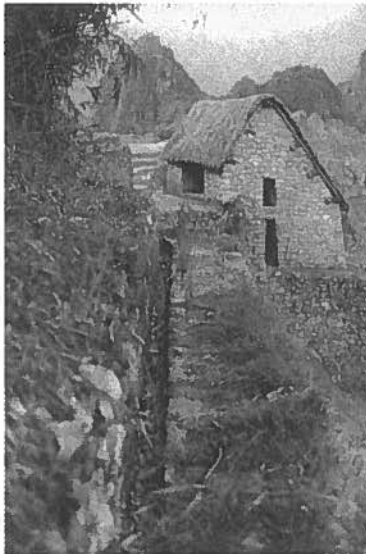
Fig. 7. Inca domestic water canal entering the Agricultural Sector. Cut granite stones forming the right bank contribute to hydraulic efficiency. The two-story building was for grain storage.

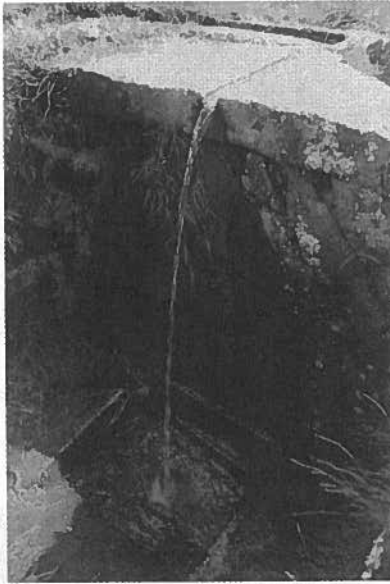
Fig. 10. Fountain No. 10 with water jetting from east to west. All other fountains jet from west to east.

Fountains 7 through 15 would be similar to the rest, with no special hydraulic specialties incorporated into them, except between Fountains 9 and 10 and at No. 12. Here the designers used their ingenuity and engineering skills to reverse the flow direction of Fountain 10 by carrying the water through a channel built within the wall (Fig. 10). Then they proceeded to cut a surface channel with two right angles so the water would flow into the fountain enclosure from the east, rather than from the west as with all the other fountains. A unique feature exists at Fountain 12 where the stonecutters shaped a smooth polished lip for the approach channel terminus to help create a good jet of water which would spring free from the back wall of the fountain enclosure.

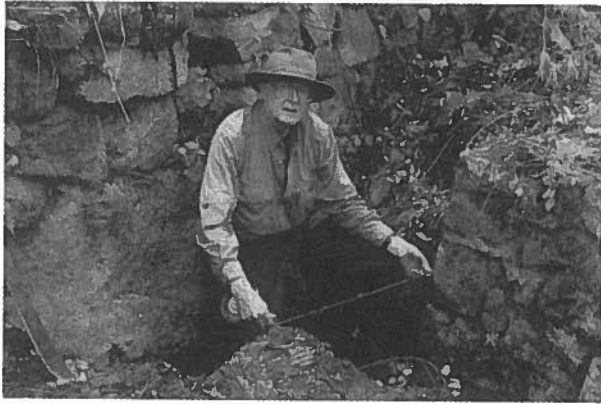
Fig. 11. Exploration was conducted on the Lower Agricultural Terraces. The author is shown at an agricultural worker's bath area which utilized drainage seepage water.

The clearing of the tropical forest and debris from several lower and less accessible agricultural terraces on the lower flanks of Machu Picchu by the paleohydrology team during 1995 and 1996 resulted in the documentation of additional fountains and baths. The first two structures found in July 1995 were simple baths, but well suited for the workers to wash up in before climbing back up to Machu Picchu with their agricultural bounty (Fig. 11). The water supply for these two baths came from the uphill subsurface drainage system of the adjacent agricultural terraces. This represents an example of water reuse at Machu Picchu.

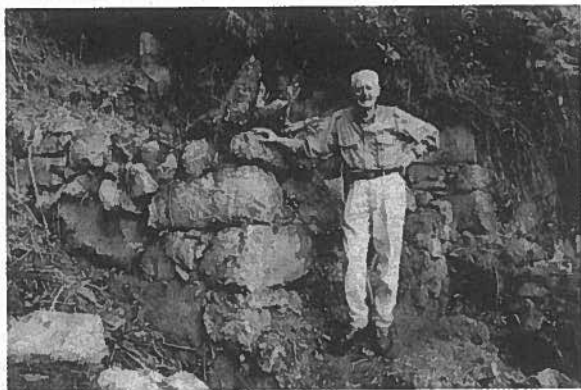
Fig. 12. The author beside one of the new ceremonial fountains recently rediscovered. An additional fountain lies to the author's left which still needs to be excavated under the authority of the Instituto Nacional de Cultura.

Then in the winter of 1996 the fountain exploration really paid off. Further north, down at the base of Huayna Picchu and with a spectacular view of the Urubamba River and the granite mountain peaks to the northeast, our team found two ceremonial fountains at the intersection of two grand granite staircases.

Ken had requested that Alfredo Valencia start cutting a trail into the area prior to the August 1996 research trip, and the trail clearing started a few weeks before my arrival (Fig. 12). Already on August 6 people in Cusco were discussing the “new fountain discovery”.

Actually, the new ceremonial fountains complete with Inca pottery pieces were not discovered, but “rediscovered”. Back in 1969 Alfredo Valencia had spotted the fountains after a forest fire had burned the mountain slopes of their vegetative cover! The locations of the fountains were not documented, but Alfredo, like most top-notch field archaeologists, had a feel for the approximate site. Again this proved that fortune smiled on our project team when we engaged Valencia as our local registered archaeologist.

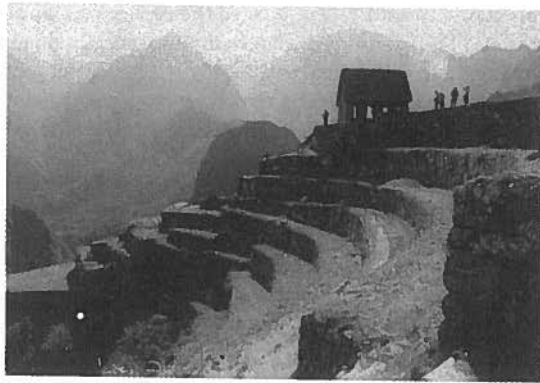
Fig. 13. Visually dominating agricultural terraces at Machu Picchu.

The size of the main agricultural areas was determined from our detailed maps (Fig. 13). It totals 4.5 hectares (11.1 acres). We needed to know what the likely precipitation was in ancient times, so we correlated the modern weather records for 1964-1977 with ice core data from the Quelccaya Ice Cap shared with us by Dr. Lonnie Thompson of the University of Ohio. The ice cap is situated halfway between Machu Picchu and Lake Titicaca. We found that the period of occupation (1450-1540 AD) likely experienced rainfall of 98 percent of the long term average, or 1940 millimeters per year (Table 3). We used the modern record for temperature and wind in our computations.

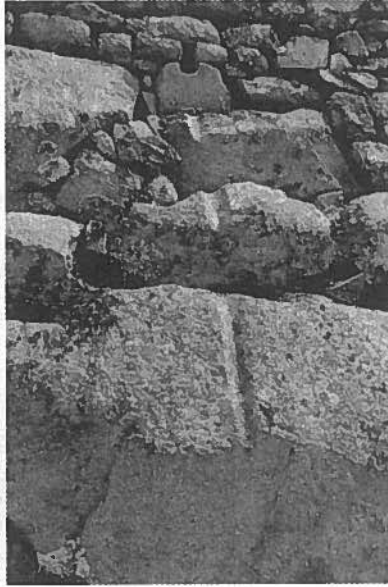
Fig. 14. An example of an Urban Drainage outlet (upper center) with a vertical drop channel cut into the stone wall rocks below the outlet.

Our research to date has left the urban drainage system to be documented last. One reason for this is the need to develop a strong background before tracing out all the many drainage routes and their contributing basins. It seems as though each time we begin to verify and document the known drainage system, more outlets are found in the various nooks and crannies of the Urban Sector. Nevertheless, we have documented some 127 drainage outlets to date. We are not sure when the drainage surprises will finally cease. A typical drainage outlet is illustrated in Fig. 14.
