CAPAY DIVERSION DAM MODERNIZATION FOR SUSTAINED IRRIGATION DEMAND

George V. Sabol, PhD, PE¹
Tim O'Halloran²
Michael Horgan³

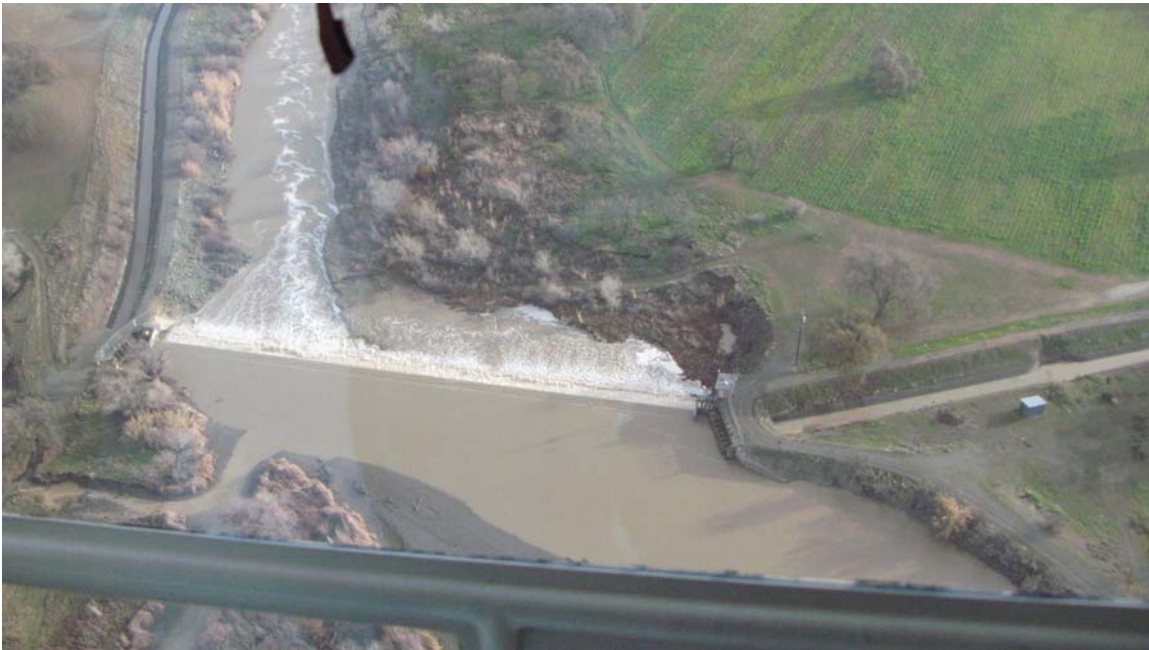
Capay Dam (Figures 2 and 3) is a concrete overflow diversion with headgates at each abutment. The Winters Canal headworks is in the right (looking downstream) abutment and the West Adams Canal headworks is in the left abutment. The dam was constructed in 1915. The overflow section is 475 feet long with low-level sluice gates and service spillways near each abutment. A short concrete apron extends downstream of the overflow section. The concrete overflow section is 10 feet high. The dam was originally fitted with timber flashboards that were repaired or replaced prior to each irrigation season. In 1993, a 5-foot high inflatable bladder was added to the crest of the dam so as to improve the efficiency of irrigation diversions while maintaining the dams' historic flood discharge capacity.

Figure 2. Aerial Photo of Capay Diversion Dam
