Habitat Improvement Techniques for Aquatic Fishery: Application Experiences at Ta-Chia River in Taiwan

Keywords: Fish habitat improvement, Structural restoration, Dam partial-removal

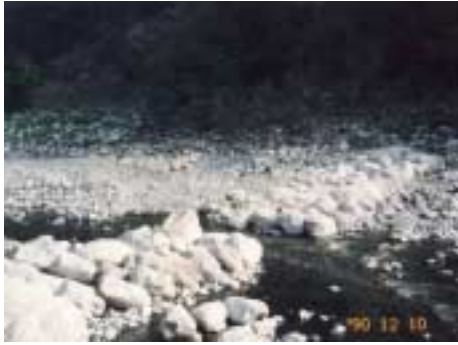
Photo 1. Rock weir of partial width

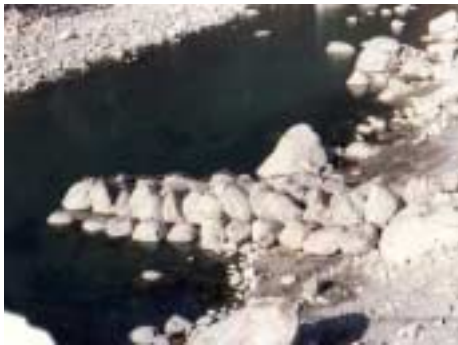
Photo 2. Rock deflector

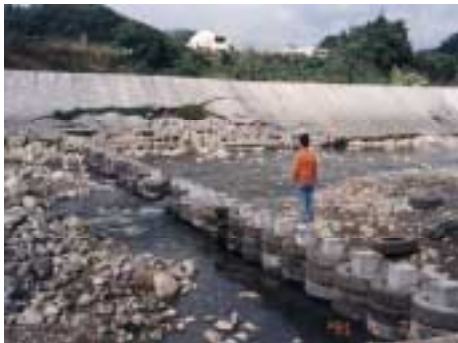
Photo 3. Tire weir with opening

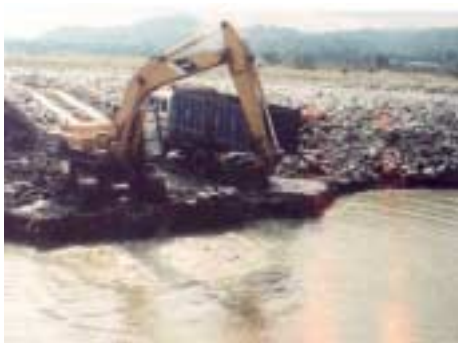
Photo 4. Channel excavation

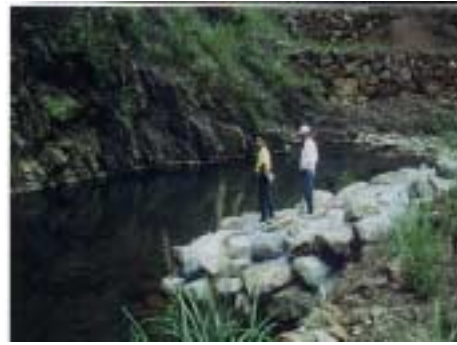
Photo 5. Concrete deflector with rock pavement

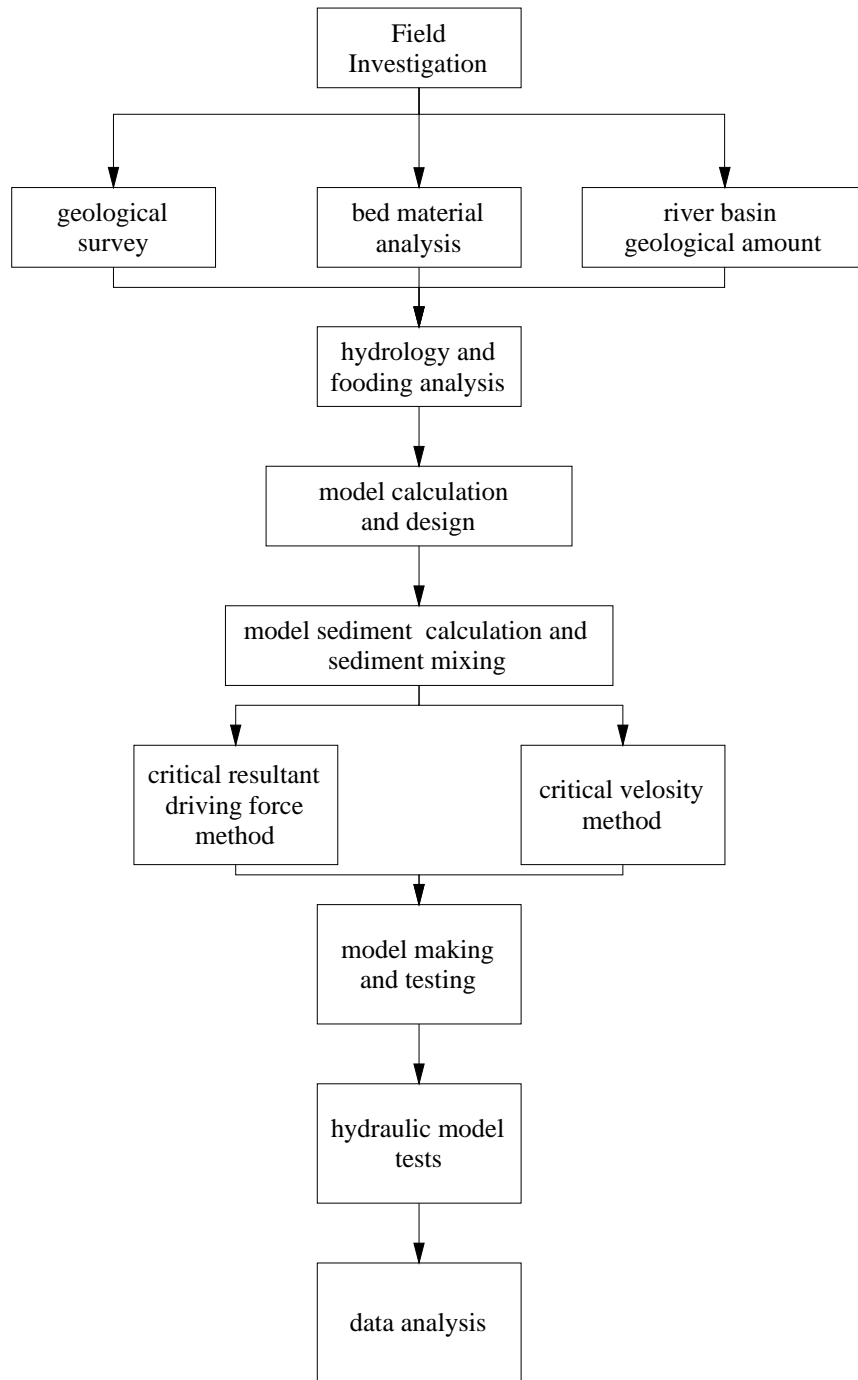
Figure 3. Flowchart of dam removal model experiments

were then processed before conducting model experiments. The main objective of flume experiment is to observe the channel reactions regarding to various combinations of opening shapes and dam partial-removal procedures. Suggestions on channel habitat enhancement for Formosan Landlocked Salmon were then concluded from experimental findings. After necessary administration procedures in several related management agencies, implementation of dam removal was finally taken into action while follow-up investigations on the change of channel morphology were scheduled to monitor and record the whole process of habitat restoration in the study reach. Consequently, the research methodology for this study was assembled by these components and illustrated as Figure 3.

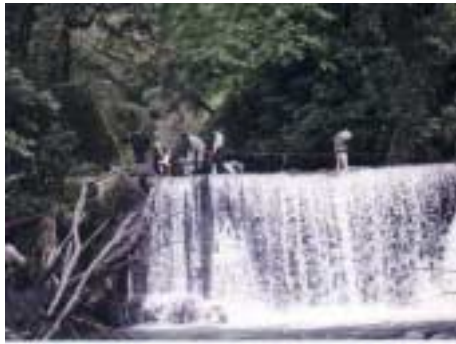
Photo 9. Dam No.4 in construction (April, 1999)

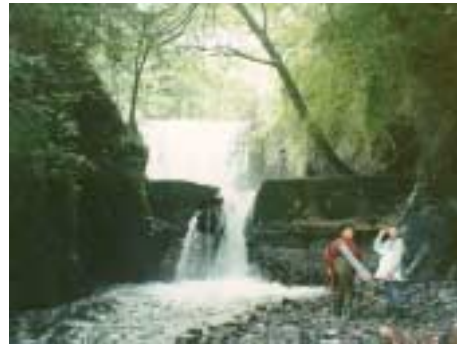
Photo 13. Dam No.2 before construction (Oct., 1997)

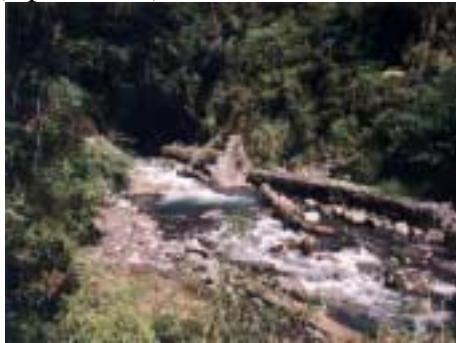
Photo 10. Dam No.4 recent condition (Oct., 2001)

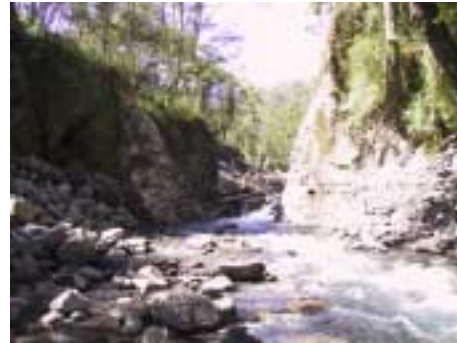
Photo 14. Dam No.2 recent condition (Oct., 2001)

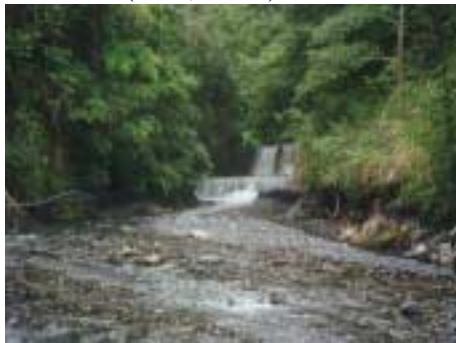
Photo 11. Dam No.3 before construction (Oct., 1997)

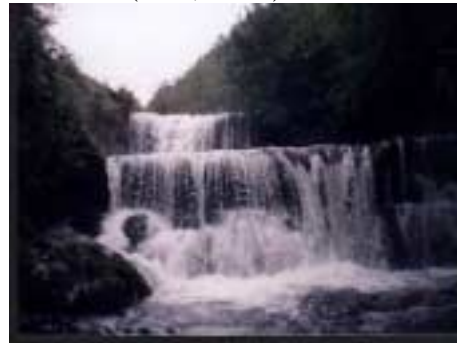
Photo 15. Dam No.1 before construction (April, 2001)

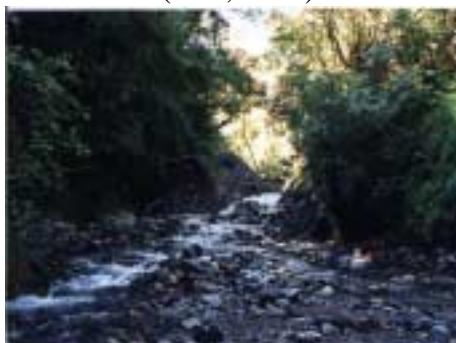
Photo 12. Dam No.3 recent condition (Nov., 2000)

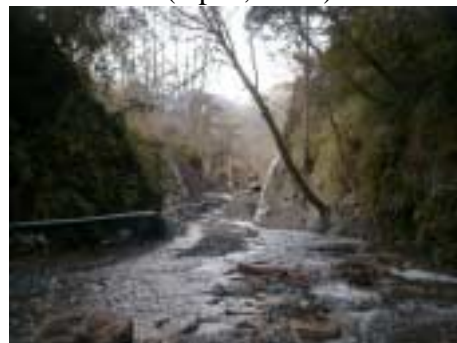
Photo 16. Dam No.1 recent condition (Dec., 2001)
